## Case Study: Pie Ranch Farmhouse Fire Rebuild

Pie Ranch, an agricultural education and sustainable advocacy non-profit, lost its historic farmhouse center in the 2020 California wildfires. The replacement structure will house farm apprentices, host events, display history, and provide office space for the organization. The new “farmhouse” structure reflects the size, form, and exterior appearance of its predecessor, while reorganizing the interior space to better serve the mix of uses. Place-based ecological and Indigenous ecological stewardship informed the building systems and material selections of site harvested strawbale insulation, earthen plaster and earthen floor, and salvaged wood. Curved, communal patio spaces and heavy wood plank details pay homage to Quiroste round houses and Yurok plank houses.

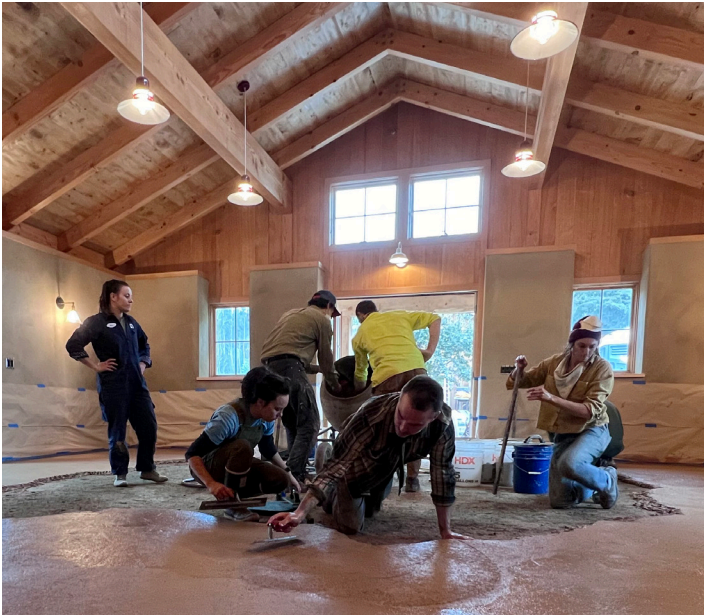
Installation of the finish coat of the earthen floor

**Top:** The earthen floor was installed in a 3-step process: a 4" base slab is poured and allowed to dry, a 1" finish coat is poured and troweled flat and smooth, finally natural oils are applied to increase durability and water repellence. Earthen slabs are a mix of clay, sand, chopped straw, and water.

1. Earthen slabs have far less carbon emissions than a concrete slab, while providing the thermal mass benefits.
2. Site soil conditions have a massive impact on the embodied carbon footprint (e.g. clay soils can require carbon intensive piers).
3. Sand cement slurry piers can be an effective lower carbon substitution for concrete piers in seismic zones where no retaining is required.

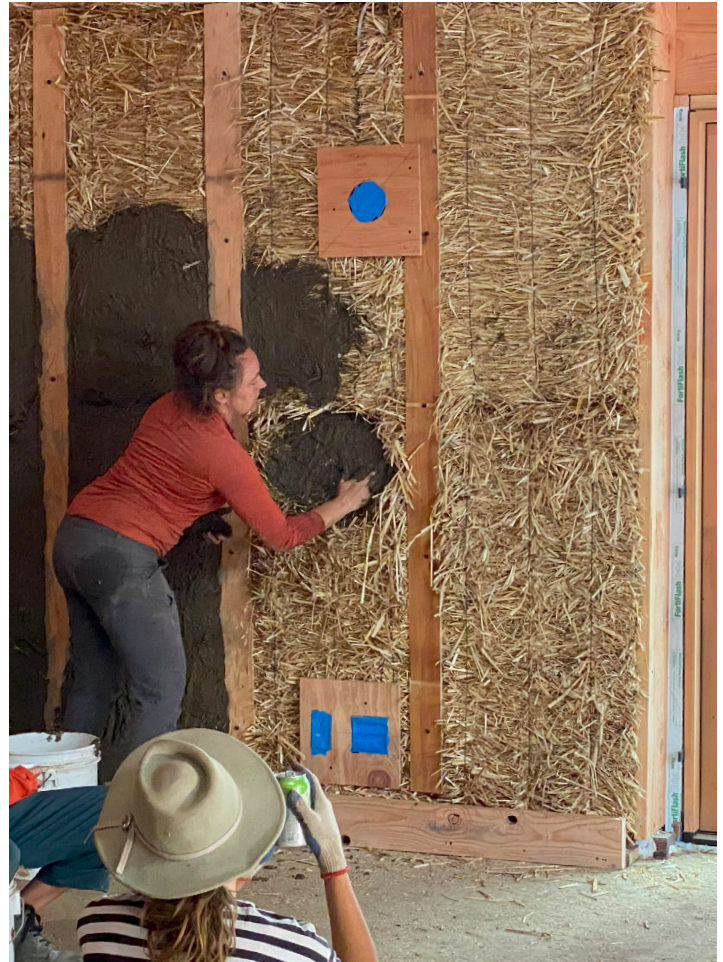
**Right:** This earthen plaster was installed in a 3-coat process: the scratch coat is worked into the strawbale, the brown coat is shaped flat and plumb, the finish coat provides a smooth finish. The scratch and brown coats used clay soil excavated during the construction of the foundation.

Application of earthen plaster over strawbale insulation
